**Flood Control Project Maintenance
Levee Inspections**
LMA District Cover Sheet
Spring 2020 Levee Inspection Results

Lake County Watershed Protection District

Spring 2020 Levee Inspection Results

Waterway			Bank	Unit Miles
Unit No. 01 Middle Creek			Left	3.35
	Spring (March - May)	Summer (June - August)	(September - November) Fall	Winter (December - February)
Unit Maintenance Rating (Fall Only)				
Date of Inspection	4/1/2020 - 4/2/2020			
DWR Inspector	Luz Dial			
Accompanied By	Yuliya Osetrova Lake County

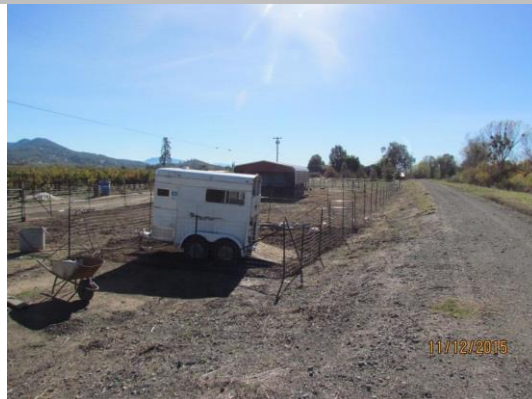
Photo 1 of 1 : SP_2020_NA0009_3_24_20200302_00010.jpg

LM Start	0.14	Rating **	M	Issue No.	24
LM End	0.18	Issue Type +	En	Location *	LS
Category	Earthen Levee			GPS Latitude/Longitude	
				Start	End
Item	Encroachments			39.188465 °	39.187905 °
				-122.907687 °	-122.907817 °
DWR ID	DWR_NA0009_01_f_2019_24				
Comment Code					
FE : Fence					
Inspector Comment					
The landowner needs to move the fence outside of the levee R/W line, which is 5' landward of the levee toe per As-builts CC-4-4-29.

View of the fence along the landside toe.

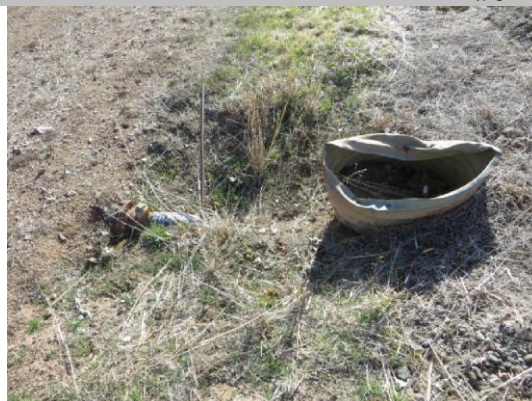
Photo 1 of 3 : UCIP_SP_2020_55696_49782.jpg

DS_ID:21193
FS_ID:55696
EP_NO: 5237
Repair Type: Non-Urgent
Crossing Status: Found
UCIP Comments: 10/16/2019 Record remains Non-Urgent; crossing has been abandoned. Owner will need to coordinate with CVFPB to remove or abandon crossing per Title 23 requirements. The UCIP inspection was completed with DWR Inspector, L. Dial, and LMA representative, S. Webb. (O. Magana - DWR UCIP)01/09/2014 Pipe appears abandoned and should be done so properly. (W. Wylie - DWR UCIP)
FIELD_STRUCT_DESC: *ABANDONED* 6-inch coated steel irrigation pipe possibly sleeved through an 8-inch steel pipe, 3 feet below the crown. Siphon breaker in 24-inch corrugated metal riser unit on the landside (LS) slope. Reinforced concrete cutoff wall at center of levee. Butterfly valve on the waterside (WS) at pump on concrete base on the WS bank. Pole on the WS berm with overhead power line supplying electricity to the pump. (Installed under Permit No. 5237, 1966 - Moitoyo Brothers, Inc.). [Additional Reference(s): DWR Levee Log, 2005. USACE Sacramento O&M Manual 506.2, August 1961, (HLM 0.54), Station M296+75, 8-inch pipe, dwg no. CC-4-4-29, Index Sheet 6: page 6, 40 of 64].

Pipe and siphon breaker visible on LS slope.

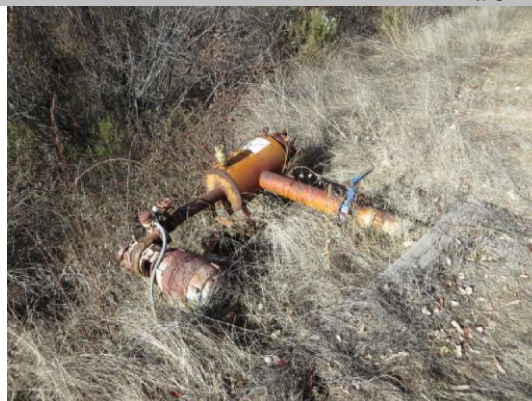
Photo 3 of 3 : UCIP_SP_2020_55696_49780.jpg

Pump and butterfly valve on WS berm.

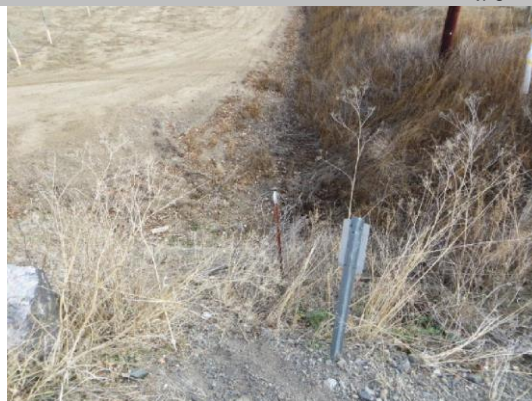
Photo 1 of 3 : UCIP_SP_2020_55693_49785.jpg

Comment Code					
Inspector Comment					
DS_ID:21194 FS_ID:55693 EP_NO: 11468 Repair Type: Non-Urgent Crossing Status: Found UCIP Comments: 10/16/2019 Record has been updated from No Action Needed to Non-Urgent; need to audit record to confirm owner. Crossing has been internally inspected under the DWR DMP Phase 1 project. Inspection report is still not available. The UCIP inspection was completed with DWR Inspector, L. Dial, and LMA representative, S. Webb. (O. Magana - DWR UCIP) FIELD_STRUCT_DESC: 24-inch corrugated metal drainage pipe through the levee, 8 feet below the crown. Flap gate on the waterside (WS) end. Concrete headwalls on both ends. (Pipe retained through the levee under Automatic Board Order (ABO) issued as Permit No. 11468, 1975 - Moitozo Brothers, Inc.). [Additional Reference(s): DWR Levee Log, 2005. USACE Sacramento O&M Manual 506.2, August 1961, Station M293+50, 24-inch pipe, dwg no. CC-4-4-29, Index Sheet 6: page 6, 40 of 64]. FS Date: 10/16/2019 3:58:00 PM

Drain pipe visible at concrete headwall on LS toe.

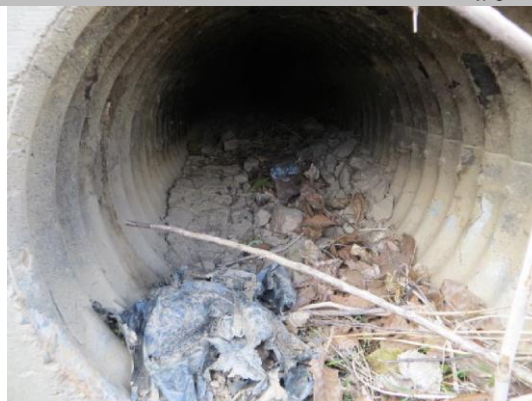
Photo 3 of 3 : UCIP_SP_2020_55693_49783.jpg

CMP as visible from LS toe.

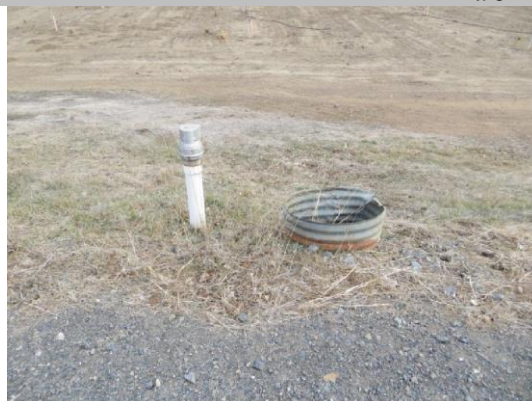
Photo 1 of 3 : UCIP_SP_2020_55697_49789.jpg

Comment Code					
Inspector Comment					
DS_ID:21196 FS_ID:55697 EP_NO: N/A Repair Type: Non-Urgent Crossing Status: Found UCIP Comments: 10/16/2019 Record remains Non-Urgent; crossing has been abandoned. Owner will need to coordinate with CVFPB to remove or abandon crossing per Title 23 requirements. The UCIP inspection was completed with DWR Inspector, L. Dial, and LMA representative, S. Webb. (O. Magana - DWR UCIP)01/09/2014 Pump and pipe appear abandoned and should be done so properly. (W. Wylie - DWR UCIP) FIELD_STRUCT_DESC: *ABANDONED* 8-inch steel irrigation pipe through the levee, 3 feet below the crown. Siphon breaker in 24-inch corrugated metal riser unit on the landside (LS) slope. Pump on the waterside (WS) bank with a butterfly valve. Service pole on the WS berm. (Moitozo Brothers, Inc.). [Additional Reference(s): DWR Levee Log, 2005. USACE Sacramento O&M Manual 506.2, August 1961, (HLM 0.83), Station M281+70, 8-inch pipe, dwg no. CC-4-4-29, Index Sheet 5: page 5, 39 of 64]. FS Date: 10/16/2019 3:59:00 PM

Siphon breaker in 24-inch cmp riser with vent on LS shoulder.

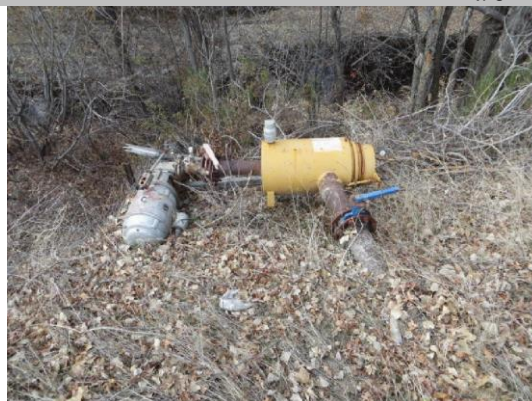
Photo 3 of 3 : UCIP_SP_2020_55697_49787.jpg

Pump and butterfly valve visible on WS berm.

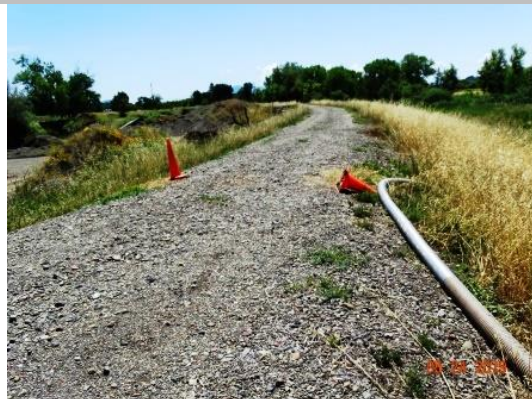
Photo 2 of 2 : SP_2020_NA0009_3_45_20200302_00017.jpg

LM Start	2.10	Rating **	U	Issue No.	45 (cont)
LM End	2.10	Issue Type +	En	Location *	LS
Category	Earthen Levee			GPS Latitude/Longitude	
				Start	End
Item	Encroachments			39.162198 °	39.162198 °
				-122.915488 °	-122.915488 °
DWR ID	DWR_NA0009_01_s_2019_45

View looking downstream at a metal hose that ran across the levee crown. Spring 2019

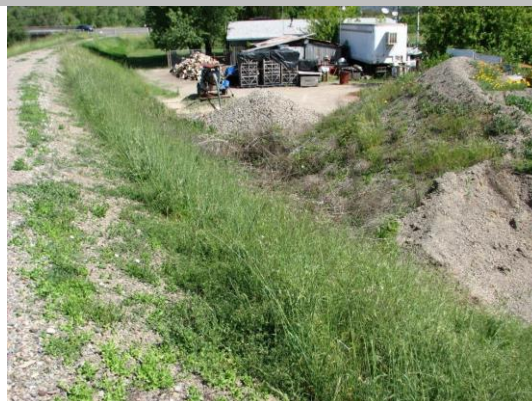
Photo 1 of 1 : SP_2020_NA0009_3_26_20200302_00012.jpg

LM Start	2.12	Rating **	U	Issue No.	26
LM End	2.12	Issue Type +	En	Location *	LS
Category	Earthen Levee			GPS Latitude/Longitude	
				Start	End
Item	Encroachments			39.161995 °	39.161995 °
				-122.915383 °	-122.915383 °
DWR ID	DWR_NA0009_01_s_2016_26				
Comment Code					
MA : Material					
Inspector Comment					
Remove large gravel piles from the LS toe. There also is a gate that does not appear to be authorized.

5/2/2016: Remove large gravel piles from L/S toe.

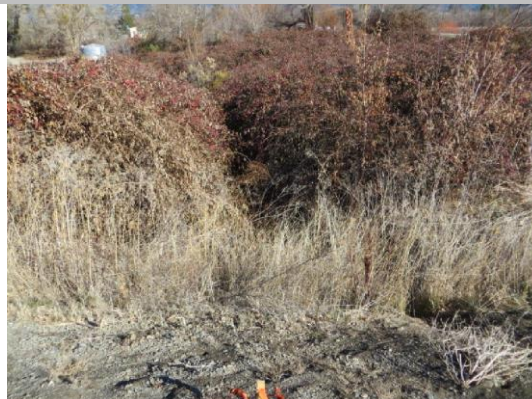
Photo 1 of 3 : UCIP_SP_2020_55702_49853.jpg

Comment Code					
Inspector Comment					
DS_ID:21240 FS_ID:55702 EP_NO: 11460 Repair Type: Non-Urgent Crossing Status: Found UCIP Comments: 10/16/2019 Record has been updated from No Action Needed to Non-Urgent; need to audit record to confirm owner. Crossing has been internally inspected under the DWR DMP Phase 1 project. Inspection report is still not available. The UCIP inspection was completed with DWR Inspector, L. Dial, and LMA representative, S. Webb. (O. Magana - DWR UCIP) FIELD_STRUCT_DESC: 1 of 2: 36-inch corrugated metal drainage pipe through the levee, 9 feet below the crown. Flap gate on the waterside (WS) end. Concrete headwalls on both ends. (two 36-inch pipes [HLM 2.26] retained under Automatic Board Order (ABO) issued as Permit No. 11460, 1975 - Robert L. and Lavona Gentry). [Additional Reference(s): DWR Levee Log, 2005. USACE Sacramento O&M Manual 506.2, August 1961, (HLM 2.26), Station M206+00, two 36-inch pipes, dwg no. CC-4-4-29, Index Sheet 4: page 4, 38 of 64]. FS Date: 10/16/2019 3:56:00 PM

Pipe and Concrete headwall visible on LS toe.

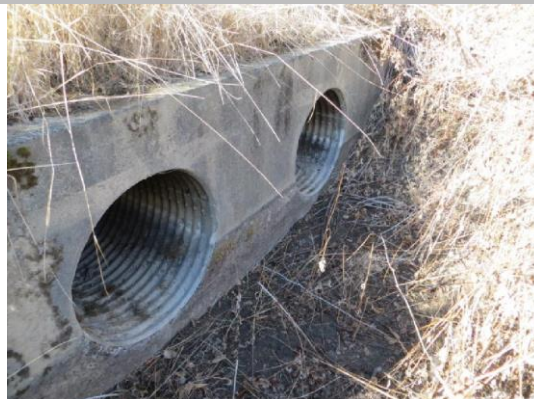
Photo 2 of 3 : UCIP_SP_2020_55703_49848.jpg

Concrete headwall and pipe visible on LS toe.

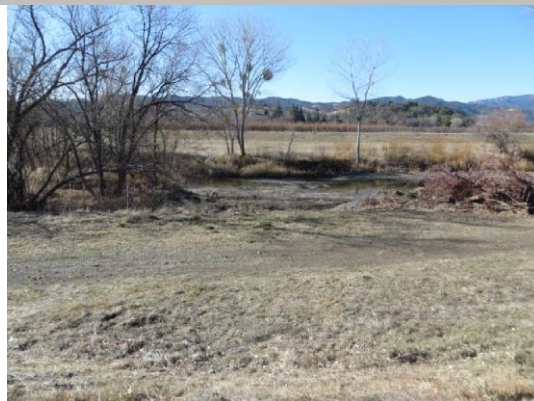
Photo 3 of 3 : UCIP_SP_2020_55703_49847.jpg

Concrete headwall and pipe visible on WS berm.

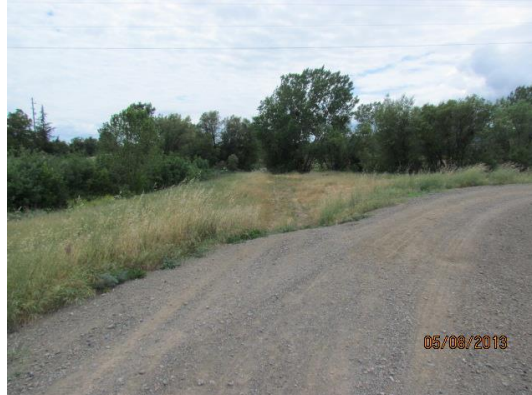
Photo 1 of 1 : SP_2020_NA0009_3_13_20200302_00005.jpg

LM Start	2.29	Rating **	M	Issue No.	13
LM End	2.29	Issue Type +	Ma	Location *	WS
Category	Earthen Levee			GPS Latitude/Longitude	
				Start	End
Item	Slope Stability			39.160285 °	39.160285 °
				-122.913481 °	-122.913481 °
DWR ID	DWR_NA0009_01_s_2013_13				
Comment Code					
S3 : Repair the levee slope damaged by vehicle traffic and prevent access where possible.					
Inspector Comment

View of the vehicle erosion along the waterside slope.

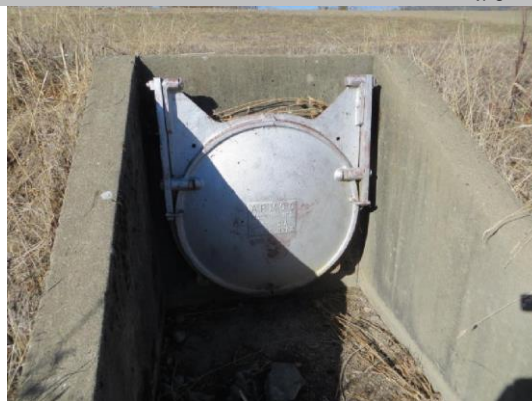
Photo 3 of 3 : UCIP_SP_2020_55705_49860.jpg

Comment Code						
Inspector Comment						
DS_ID:21199 FS_ID:55705 EP_NO: 11460 Repair Type: Non-Urgent Crossing Status: Found UCIP Comments: 10/16/2019 Record remains Non-Urgent, need to audit record to confirm owner. Crossing has been internally inspected under the DWR DMP Phase 1 project. Inspection report is still not available. The UCIP inspection was completed with DWR Inspector, L. Dial, and LMA representative, S. Webb. (O. Magana - DWR UCIP)01/14/2014 Heavy vegetation on LS at inlet should be remove. (W. Wylie - DWR UCIP) FIELD_STRUCT_DESC: 42-inch corrugated metal drainage pipe through the levee, 10 feet below the crown. Flap gate on the waterside (WS) end. Concrete headwall on both ends. (42-inch pipe [HLM 2.35] retained under Automatic Board Order (ABO) issued as Permit No. 11460, 1975 - Robert L. and Lavona Gentry). [Additional Reference(s): DWR Levee Log, 2005. USACE Sacramento O&M Manual 506.2, August 1961, (HLM 2.35), Station C4+90, 42-inch pipe, dwg no. CC-4-4-29, Index Sheet 4: page 4, 38 of 64]. FS Date: 10/16/2019 3:56:00 PM

Concrete U-shaped headwall and flap gate on WS berm.

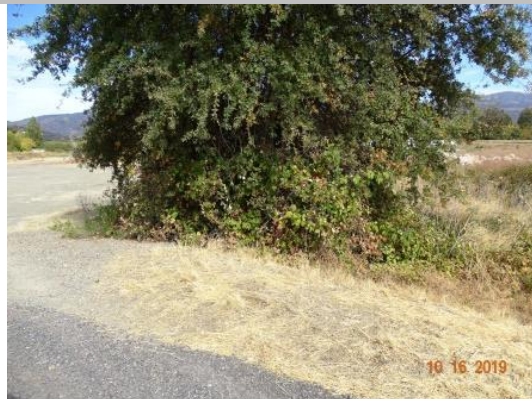
Photo 1 of 1 : SP_2020_NA0009_3_46_20200302_00018.jpg

LM Start	2.36	Rating **	M	Issue No.	46
LM End	2.40	Issue Type +	Ma	Location *	LS
Category	Earthen Levee			GPS Latitude/Longitude	
				Start	End
Item	Vegetation			39.161160 °	39.161655 °
				-122.912752 °	-122.912262 °
DWR ID	DWR_NA0009_01_s_2019_46				
Comment Code					
V2 : Remove the wild growth other than native grasses from the levee slopes.					
Inspector Comment

View of wild growth on the landside slope. Fall 2019

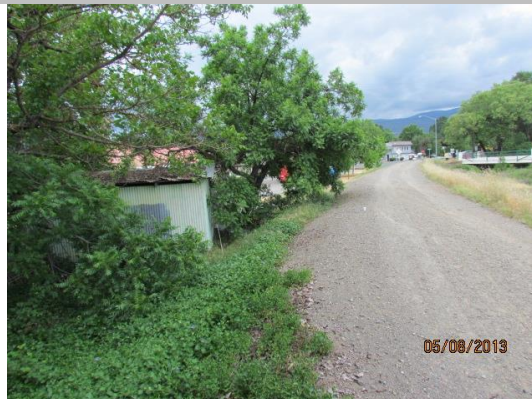
Photo 1 of 1 : SP_2020_NA0009_3_15_20200302_00007.jpg

LM Start	2.38	Rating **	M	Issue No.	15
LM End	2.43	Issue Type +	Ma	Location *	LS
Category	Earthen Levee			GPS Latitude/Longitude	
				Start	End
Item	Trim / Thin Trees			39.161381 °	39.161935 °
				-122.912551 °	-122.911883 °
DWR ID	DWR_NA0009_01_s_2013_15				
Comment Code					
T1 : Trim trees to at least five feet above ground level.					
Inspector Comment					
Trim the trees to at least 5 feet above the ground for visibility, and remove the vegetation from the slope.

Trim the trees up 5 feet to allow visibility. Spring 2013

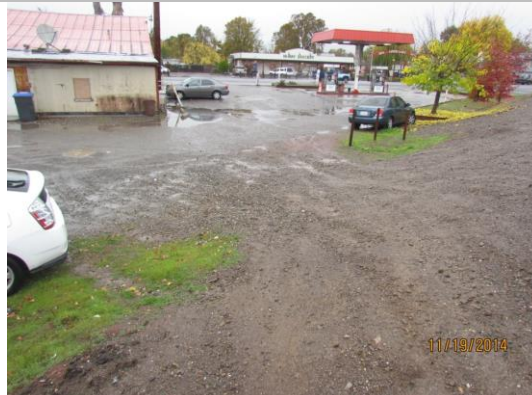
Photo 1 of 1 : SP_2020_NA0009_3_17_20200302_00009.jpg

LM Start	2.42	Rating **	M	Issue No.	17
LM End	2.42	Issue Type +	Ma	Location *	LS
Category	Earthen Levee			GPS Latitude/Longitude	
				Start	End
Item	Slope Stability			39.161802 °	39.161802 °
				-122.912020 °	-122.912020 °
DWR ID	DWR_NA0009_01_s_2013_17				
Comment Code					
S3 : Repair the levee slope damaged by vehicle traffic and prevent access where possible.					
Inspector Comment

View of the erosion caused by vehicle traffic over the landside slope.
Fall 2014

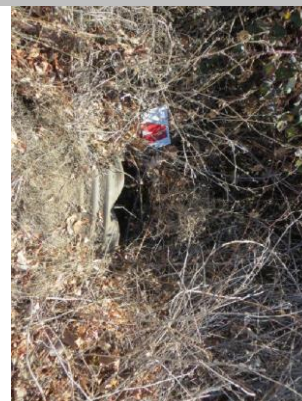
Comment Code						
Inspector Comment						
DS_ID:21200 FS_ID:55707 EP_NO: 11458 Repair Type: Urgent Crossing Status: Found UCIP Comments: 10/16/2019 Record remains Urgent due to holes visible inside pipe wall on the WS outlet and no flap gate located on the WS. Currently, there is no way to prevent water from flowing from WS to LS. Flooding occurred during the 2017 highwater event. Need to audit record to confirm owner. Crossing has been internally inspected under the DWR DMP Phase 1 project. Inspection report is still not available. The UCIP inspection was completed with DWR Inspector, L. Dial, and LMA representative, S. Webb. (O. Magana - DWR UCIP)09/06/2018 Inspected this crossing per the request of LMA Rep, Scott Webb. WS pipe does not have a WS closure device and has caused flooding of the roadway due to the flat LS pipe slope and roadway. Classifying Urgent until the flooding risk is reduced by the installation of a WS gate valve (D. Sanoski - DWR UCIP). FIELD_STRUCT_DESC: 36-inch corrugated metal drainage pipe through the levee, 8 feet below the crown. 24-inch by 36-inch drainage drop inlet visible at edge of pavement on Highway 20. Open on the waterside (WS) end. (Pipe retained through the levee under Automatic Board Order (ABO) issued as Permit No. 11458, 1975 - Fernande and Guido Deghetaldi). [Additional Reference(s): DWR Levee Log, 2005]. FS Date: 10/16/2019 3:54:00 PM

Outlet visible on WS toe.

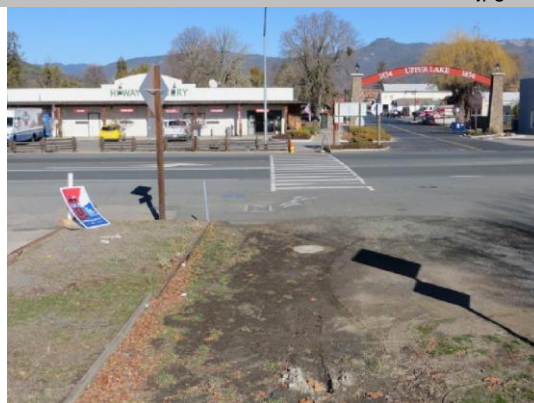
Photo 3 of 3 : UCIP_SP_2020_55707_50040.jpg

Stormdrain drop inlet visible at edge of pavement on HWY 20.

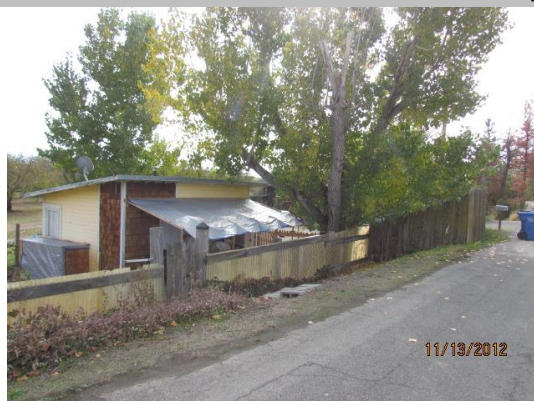
Photo 1 of 1 : SP_2020_NA0009_3_7_20200302_00004.jpg

LM Start	2.47	Rating **	M	Issue No.	7
LM End	2.59	Issue Type +	En	Location *	LS
Category	Earthen Levee			GPS Latitude/Longitude	
				Start	End
Item	Encroachments			39.161692 °	39.160217 °
				-122.911748 °	-122.912957 °
DWR ID	DWR_NA0009_01_s_2012_7				
Comment Code					
BU : Building					
Inspector Comment

View of a building & fence along the toe of the levee. Fall 2012

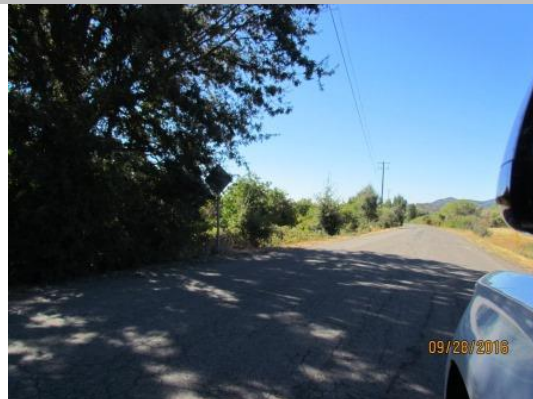
Photo 1 of 1 : SP_2020_NA0009_3_3_20200302_00001.jpg

LM Start	2.48	Rating **	M	Issue No.	3
LM End	2.55	Issue Type +	En	Location *	LS
Category	Earthen Levee			GPS Latitude/Longitude	
				Start	End
Item	Vegetation			39.161615 °	39.160804 °
				-122.911733 °	-122.912536 °
DWR ID	DWR_NA0009_01_s_2012_3				
Comment Code					
V6 : Landscaping					
Inspector Comment					
The landowner needs to thin out thick brush on the other side of the wire fence along the levee toe easement.

View of the vegetation along the landside slope. Fall 2016

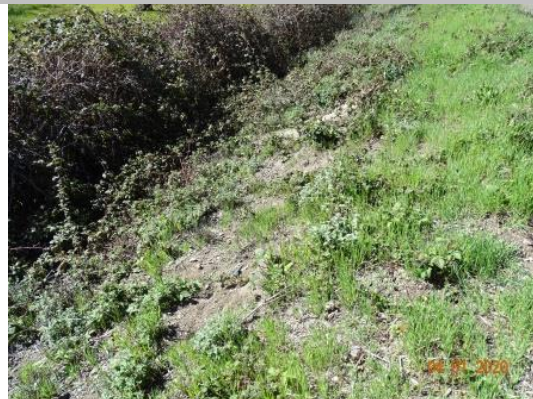
Photo 1 of 1 : SP_2020_NA0009_3_48_20200403_00044.jpg

LM Start	2.49	Rating **	U	Issue No.	48
LM End	2.52	Issue Type +	Ma	Location *	LS
Category	Earthen Levee			GPS Latitude/Longitude	
				Start	End
Item	Animal Control			39.161472 °	39.161082 °
				-122.911822 °	-122.912258 °
DWR ID	DWR_NA0009_01_s_2019_48				
Comment Code					
A3 : No rodents visible, but rodent burrows visible; need to backfill and compact or grout burrows.					
Inspector Comment					
Backfill animal holes on both sides of the levee.

View of animal holes on the landside slope. Spring 2020

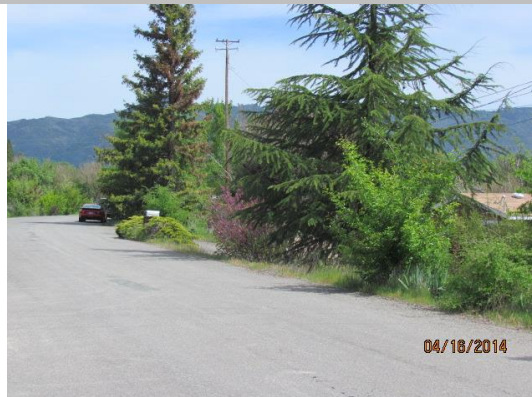
Photo 1 of 1 : SP_2020_NA0009_3_5_20200302_00003.jpg

LM Start	2.58	Rating **	M	Issue No.	5
LM End	2.66	Issue Type +	En	Location *	LS
Category	Earthen Levee			GPS Latitude/Longitude	
				Start	End
Item	Vegetation			39.160443 °	39.159308 °
				-122.912845 °	-122.913417 °
DWR ID	DWR_NA0009_01_s_2012_5				
Comment Code					
V6 : Landscaping					
Inspector Comment

View of the landscape along the landside slope. Spring 2014

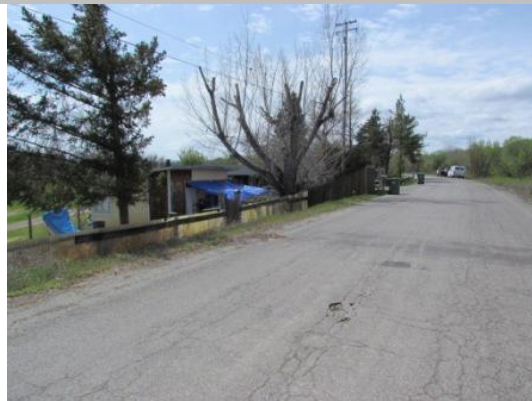
Photo 1 of 1 : SP_2020_NA0009_3_4_20200302_00002.jpg

LM Start	2.58	Rating **	M	Issue No.	4
LM End	2.61	Issue Type +	En	Location *	LS
Category	Earthen Levee			GPS Latitude/Longitude	
				Start	End
Item	Encroachments			39.160398 °	39.160020 °
				-122.912837 °	-122.913186 °
DWR ID	DWR_NA0009_01_s_2012_4				
Comment Code					
FE : Fence					
Inspector Comment

View of the fences at the landside toe.

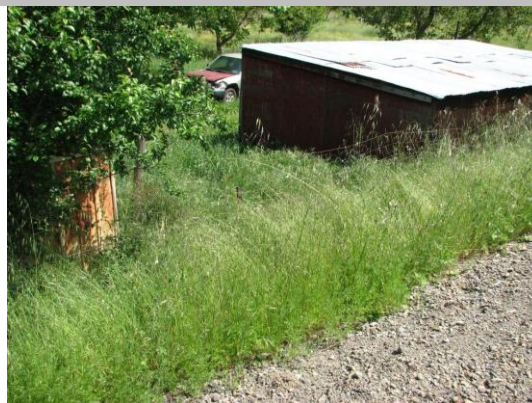
Photo 1 of 1 : SP_2020_NA0009_3_31_20200302_00013.jpg

LM Start	2.93	Rating **	U	Issue No.	31
LM End	2.93	Issue Type +	En	Location *	LS
Category	Earthen Levee			GPS Latitude/Longitude	
				Start	End
Item	Encroachments			39.155553 °	39.155553 °
				-122.914560 °	-122.914560 °
DWR ID	DWR_NA0009_01_s_2016_31				
Comment Code					
BU : Building					
Inspector Comment					
Two wooden sheds - one large, one small - with metal roofs appear to be unauthorized. The landowner needs to move the wire fence to at least 5' landward of the levee toe (R/W per As-builts CC-4-4-29).

5/2/2016: Remove or relocate 2 unpermitted sheds on L/S slope and toe.

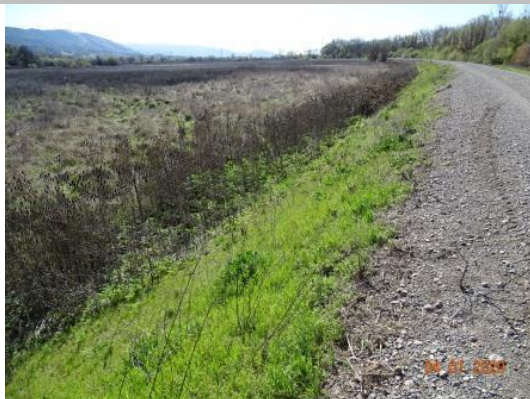
Photo 1 of 1 : SP_2020_NA0009_3_30_20200403_00043.jpg

LM Start	3.31	Rating **	M	Issue No.	30
LM End	3.41	Issue Type +	Ma	Location *	LS
Category	Earthen Levee			GPS Latitude/Longitude	
				Start	End
Item	Vegetation			39.150272 °	39.148942 °
				-122.913105 °	-122.912233 °
DWR ID	DWR_NA0009_01_s _ 2020_30				
Comment Code					
V2 : Remove the wild growth other than native grasses from the levee slopes.					
Inspector Comment

View of wild growth along the levee slope and toe. Spring 2020

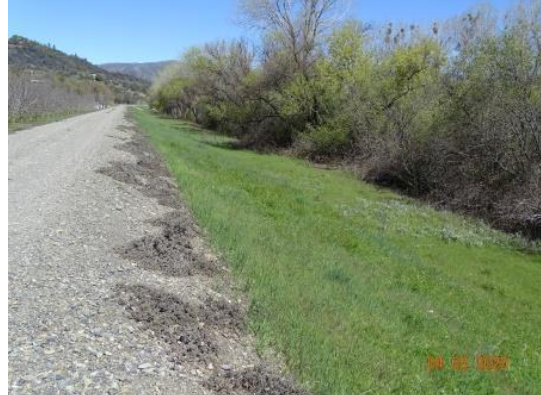
Photo 1 of 1 : SP_2020_NA0009_4_39_20200513_00068.jpg

LM Start	0.00	Rating **	A	Issue No.	39
LM End	2.56	Issue Type +	Ma	Location *	WS
Category	Earthen Levee			GPS Latitude/Longitude	
				Start	End
Item	Vegetation			39.189814 °	39.155307 °
				-122.907951 °	-122.915745 °
DWR ID	DWR_NA0009_02_s_2020_39				
Comment Code					
V1 : Control annual grass and weeds on the levee slopes and easements.					
Inspector Comment

View of well-maintained waterside vegetation. Spring 2020

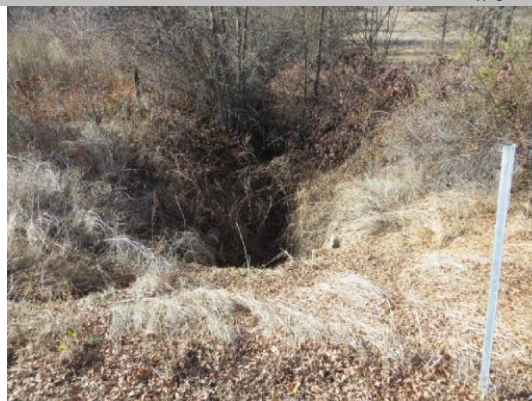
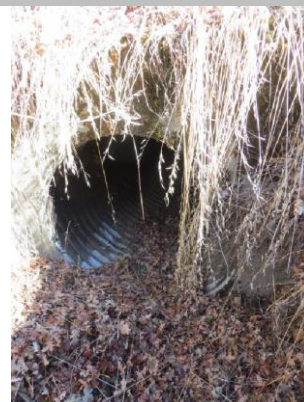
Comment Code						
Inspector Comment						
DS_ID:21201 FS_ID:55713 EP_NO: 11485 Repair Type: Non-Urgent Crossing Status: Found UCIP Comments: 10/23/2019 Record has been updated from No Action Needed to Non-Urgent; need to audit record to confirm owner. Crossing has been internally inspected under the DWR DMP Phase 1 project. Inspection report is still not available. The UCIP inspection was completed with DWR Inspector, L. Dial, and LMA representative, S. Webb. (O. Magana - DWR UCIP) FIELD_STRUCT_DESC: 42-inch corrugated metal drainage pipe through the levee, 8.5 feet below the crown. Flap gate on the waterside (WS). Concrete headwalls on both ends. (42-inch pipe [HLM 0.13] retained under Automatic Board Order (ABO) issued as Permit No. 11485, 1975 - John and Vivian Strickfaden). [Additional Reference(s): DWR Levee Log, 2005. USACE Sacramento O&M Manual 506.2, August 1961, (HLM 0.13), Station M315+75, 42-inch pipe, dwg no. CC-4-4-29, Index Sheet 6: page 6, 40 of 64]. FS Date: 10/23/2019 1:44:00 PM

Pipe and headwall visible at LS toe in drainage swale.

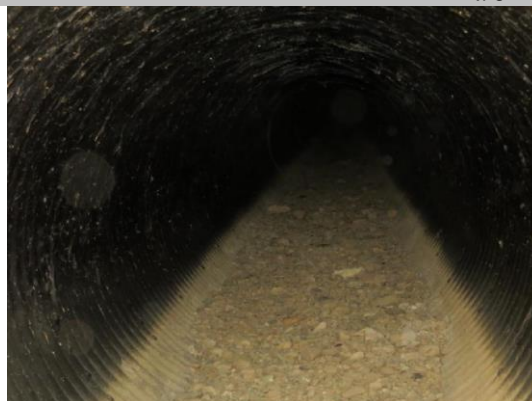
Photo 3 of 3 : UCIP_SP_2020_55713_50047.jpg

LM Start	0.14	Rating **	M	Issue No.	55 (cont)
LM End	0.14	Issue Type +	Ma	Location *	
Category	Supplemental		GPS Latitude/Longitude		
			Start	End	
Item	DWR UCIP LMA Responsibility		39.187919 °	39.187919 °	
			-122.908631 °	-122.908631 °	
DWR ID	21201

Pipe with some sediment at flowline.

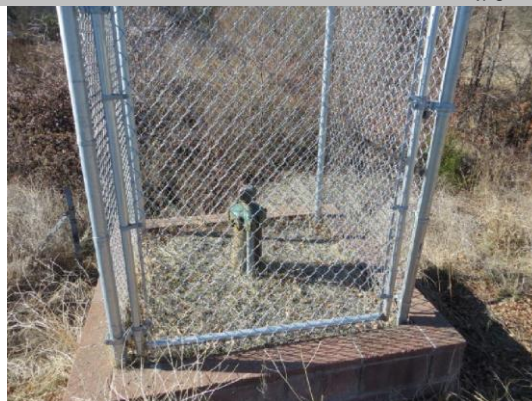
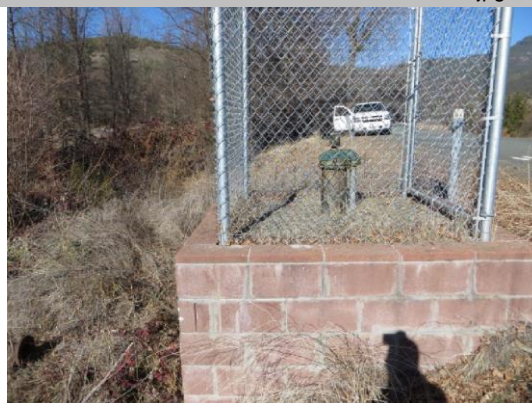
DS_ID:21202
FS_ID:55714
EP_NO: 11485
Repair Type: Non-Urgent
Crossing Status: Found
UCIP Comments: 10/23/2019 Record has been updated from No Action Needed to Non-Urgent; need to audit record to confirm owner. The UCIP inspection was completed with DWR Inspector, L. Dial, and LMA representative, S. Webb. (O. Magana - DWR UCIP)
FIELD_STRUCT_DESC: 4-inch steel irrigation pipe through the levee, 3 feet below the crown. Siphon breaker at well on the landside (LS) slope. Irrigation well with cinderblock retaining wall on the LS slope. (Pipe retained under Automatic Board Order (ABO) issued as Permit No. 11485, 1975 - John and Vivian Strickfaden). [Additional Reference(s): DWR Levee Log, 2005. USACE Sacramento O&M Manual 506.2, August 1961, (HLM 0.13), Station M315+50, 4-inch pipe, dwg no. CC-4-4-29, Index Sheet 6: page 6, 40 of 64].
FS Date: 10/23/2019 1:45:00 PM

Chainlink fence and cinderblock box around well/pipe on LS shoulder.

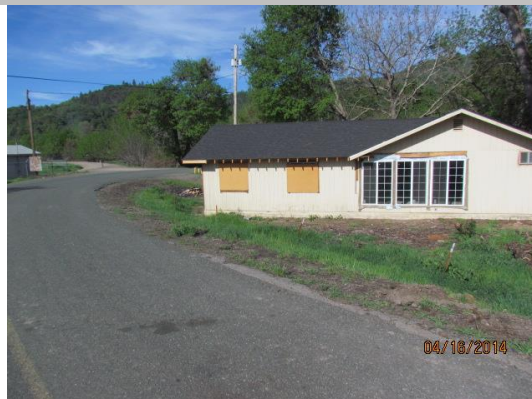
Photo 1 of 1 : SP_2020_NA0009_4_1_20200302_00001.jpg

LM Start	0.20	Rating **	U	Issue No.	1
LM End	0.20	Issue Type +	En	Location *	LS
Category	Earthen Levee			GPS Latitude/Longitude	
				Start	End
Item	Encroachments			39.187039 °	39.187039 °
				-122.908880 °	-122.908880 °
DWR ID	DWR_NA0009_02_s_2016_1				
Comment Code					
BU : Building					
Inspector Comment

View of the building on the landside toe. Spring 2014

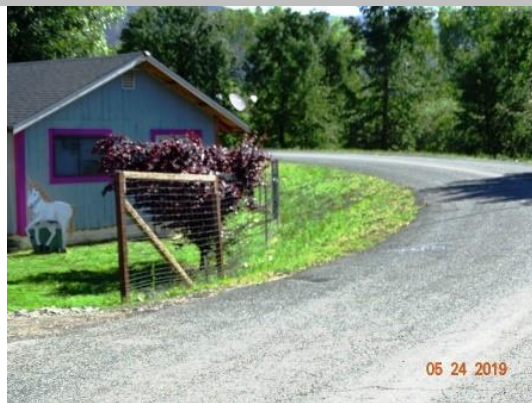
Photo 1 of 1 : SP_2020_NA0009_4_33_20200302_00013.jpg

LM Start	0.21	Rating **	M	Issue No.	33
LM End	0.21	Issue Type +	En	Location *	LS
Category	Earthen Levee			GPS Latitude/Longitude	
				Start	End
Item	Encroachments			39.186940 °	39.186940 °
				-122.909067 °	-122.909067 °
DWR ID	DWR_NA0009_02_s_2019_33				
Comment Code					
FE : Fence					
Inspector Comment					
A metal and wooden fence with mesh is installed at the levee toe.

View looking upstream at a metal and wooden fence at the levee toe.
Spring 2019

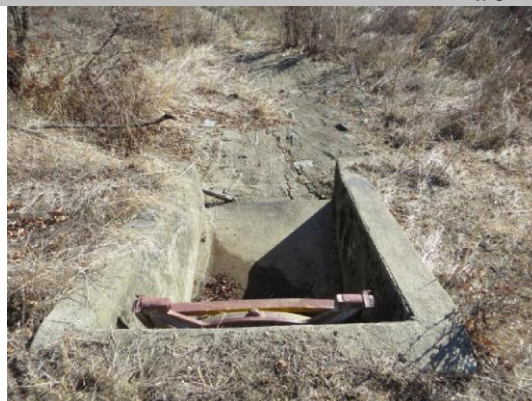
Photo 3 of 3 : UCIP_SP_2020_55717_50320.jpg

Comment Code						
Inspector Comment						
DS_ID:21204 FS_ID:55717 EP_NO: 11484 Repair Type: Non-Urgent Crossing Status: Found UCIP Comments: 10/23/2019 Record has been updated from No Action Needed to Non-Urgent; need to audit record to confirm owner. Crossing has been internally inspected under the DWR DMP Phase 1 project. Inspection report is still not available. The UCIP inspection was completed with DWR Inspector, L. Dial, and LMA representative, S. Webb. (O. Magana - DWR UCIP) FIELD_STRUCT_DESC: 36-inch corrugated metal drainage pipe through the levee, 6 feet below the crown. Flap gate on the waterside (WS) end. Concrete headwalls on both ends. (36-inch pipe [HLM 0.23] retained under Automatic Board Order (ABO) issued as Permit No. 11484, 1975 - Rodney Snow). [Additional Reference(s): DWR Levee Log, 2005. USACE Sacramento O&M Manual 506.2, August 1961, (HLM 0.23), Station M311+10, 36-inch pipe, dwg no. CC-4-4-29, Index Sheet 6: page 6, 40 of 64]. FS Date: 10/23/2019 1:46:00 PM

Flapgate and concrete headwall on WS toe.

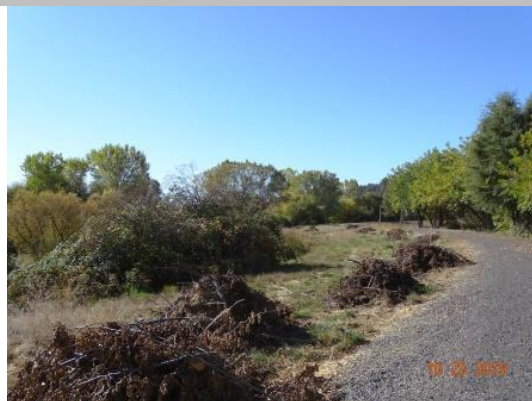
Photo 1 of 1 : SP_2020_NA0009_4_27_20200302_00007.jpg

LM Start	0.24	Rating **	M	Issue No.	27
LM End	0.28	Issue Type +	En	Location *	WS
Category	Earthen Levee			GPS Latitude/Longitude	
				Start	End
Item	Encroachments			39.186708 °	39.186210 °
				-122.909405 °	-122.909880 °
DWR ID	DWR_NA0009_02_f_2019_27				
Comment Code					
PR : Prunings					
Inspector Comment

View of prunings left on the slope. Fall 2019

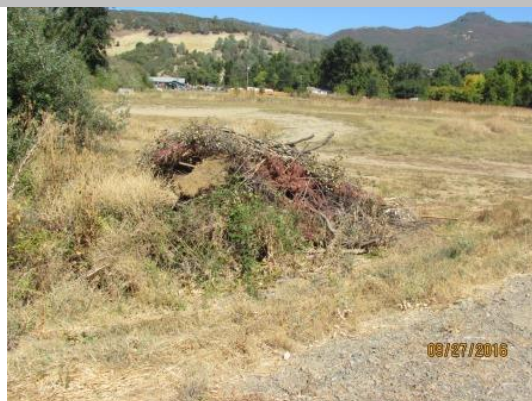
Photo 1 of 1 : SP_2020_NA0009_4_17_20200302_00005.jpg

LM Start	0.38	Rating **	M	Issue No.	17
LM End	0.38	Issue Type +	En	Location *	LS
Category	Earthen Levee			GPS Latitude/Longitude	
				Start	End
Item	Encroachments			39.185239 °	39.185239 °
				-122.911018 °	-122.911018 °
DWR ID	DWR_NA0009_02_f _ 2016_17				
Comment Code					
PR : Prunings					
Inspector Comment

View of the prunings along the landside toe. Fall 2016

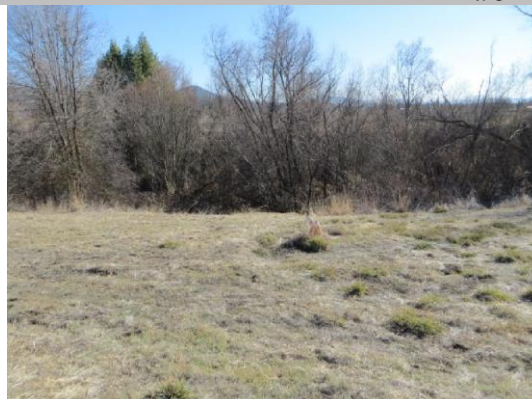
Photo 2 of 3 : UCIP_SP_2020_55718_50325.jpg

Comment Code					
Inspector Comment					
DS_ID:21206 FS_ID:55718 EP_NO: 11478 Repair Type: Non-Urgent Crossing Status: Found UCIP Comments: 10/23/2019 Record has been updated from No Action Needed to Non-Urgent; need to audit record to confirm owner. Crossing has been internally inspected under the DWR DMP Phase 1 project. Inspection report is still not available. The UCIP inspection was completed with DWR Inspector, L. Dial, and LMA representative, S. Webb. (O. Magana - DWR UCIP) FIELD_STRUCT_DESC: 42-inch corrugated metal drainage pipe through the levee, 7.7 feet below the crown. Flap gate on the waterside (WS) end. Concrete headwalls on both ends. Grouted spillway over revetment on bank. (42-inch pipe [HLM 0.38] retained under Automatic Board Order (ABO) issued as Permit No. 11478, 1975 - William D. and Dorothy L. Allison). [Additional Reference(s): DWR Levee Log, 2005. USACE Sacramento O&M Manual 506.2, August 1961, (HLM 0.38), Station M302+80, 42-inch pipe, dwg no. CC-4-4-29, Index Sheet 6: page 6, 40 of 64]. FS Date: 10/23/2019 1:47:00 PM

Flapgate and headwall off WS toe at berms edge.

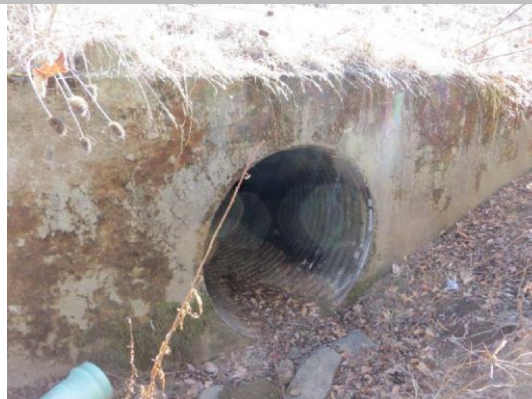
Photo 3 of 3 : UCIP_SP_2020_55718_50324.jpg

LM Start	0.39	Rating **	M	Issue No.	58 (cont)	
LM End	0.39	Issue Type +	Ma	Location *		
Category	Supplemental			GPS Latitude/Longitude		
				Start		End
Item	DWR UCIP LMA Responsibility			39.185174 °	39.185174 °	
				-122.911171 °	-122.911171 °	
DWR ID	21206

Pipe and concrete headwall at LS toe.

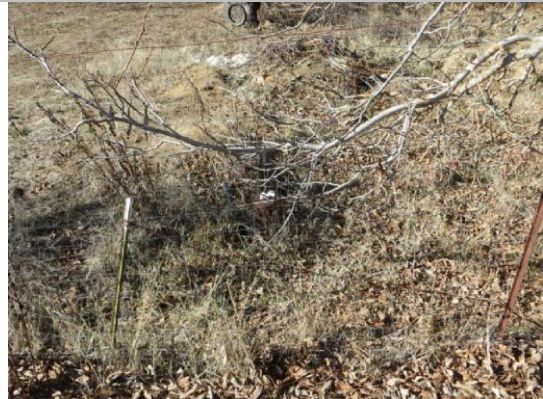
Photo 1 of 3 : UCIP_SP_2020_55719_50330.jpg

Comment Code						
Inspector Comment						
DS_ID:21207 FS_ID:55719 EP_NO: 7261 Repair Type: Non-Urgent Crossing Status: Indicator Found UCIP Comments: 10/23/2019 Record has been updated from No Action Needed to Non-Urgent; need to audit record to confirm owner. Unable to confirm line through levee. Need updated photos at this crossing. Permit records show pipe installed through levee was a galvanized pipe and not the plastic pipe the owner originally requested in application. The UCIP inspection was completed with DWR Inspector, L. Dial, and LMA representative, S. Webb. (O. Magana - DWR UCIP) FIELD_STRUCT_DESC: 1.5-inch galvanized iron irrigation pipe through the levee, 2.5 feet below the crown. (1.5-inch pipe authorized under Permit No. 7261, 1970 - George Goslowsky). FS Date: 10/23/2019 1:47:00 PM

Well head visible at LS toe.

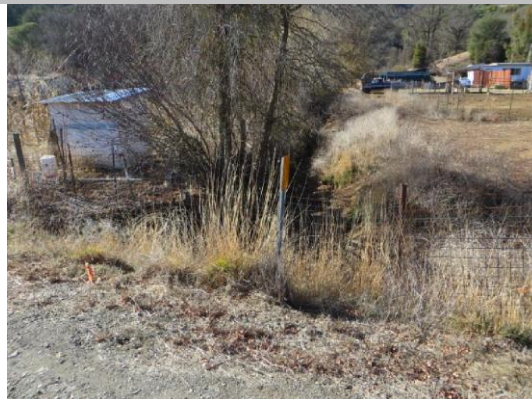
Photo 2 of 3 : UCIP_SP_2020_55723_50388.jpg

LM Start	0.48	Rating **	M	Issue No.	60 (cont)
LM End	0.48	Issue Type +	Ma	Location *	
Category	Supplemental		GPS Latitude/Longitude		
			Start	End	
Item	DWR UCIP LMA Responsibility		39.184126 °	39.184126 °	
			-122.912118 °	-122.912118 °	
DWR ID	21208

Pipe and concrete headwall on LS toe.

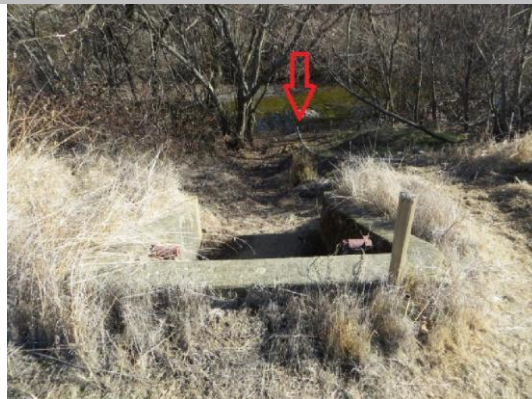
Photo 1 of 3 : UCIP_SP_2020_55720_51182.jpg

Comment Code						
Inspector Comment						
DS_ID:24761 FS_ID:55720 EP_NO: N/A Repair Type: Non-Urgent Crossing Status: Found UCIP Comments: 10/23/2019 Record remains Non-Urgent; no permit has been found authorizing encroachment. Need updated photos of levee crown and WS. The UCIP inspection was completed with DWR Inspector, L. Dial, and LMA representative, S. Webb. (O. Magana - DWR UCIP)01/14/2014 No Permit identified for crossing. (W. Wylie - DWR UCIP) FIELD_STRUCT_DESC: 1.5-inch high-density polyethylene irrigation pipe through the levee, 2.5 feet below the crown. Pipe visible on the waterside (WS) berm and slope. Pump house on the LS toe. FS Date: 10/23/2019 1:49:00 PM

Pipe visible just downstream from stormdrain.

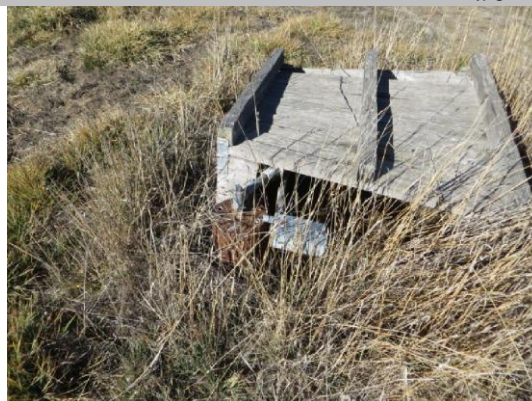
Photo 1 of 3 : UCIP_SP_2020_55729_50401.jpg

Comment Code						
Inspector Comment						
DS_ID:21249 FS_ID:55729 EP_NO: 8513 Repair Type: Non-Urgent Crossing Status: Found UCIP Comments: 10/23/2019 Record has been updated from No Action Needed to Non-Urgent; recommend auditing permit to find current owner and identify if encroachment is still in use. Encroachment appears to be abandoned. If crossing is no longer in use, the owner will need to coordinate with the CVFPB to properly remove or abandon per Title 23 requirements. The UCIP inspection was completed with DWR Inspector, L. Dial, and LMA representative, S. Webb. (O. Magana - DWR UCIP) FIELD_STRUCT_DESC: 2 of 2: 0.75-inch steel electrical conduit through the levee, 2 feet below the levee. Steel cutoff wall around conduit at center of levee. Well with 8-inch casing on the waterside (WS) slope. (well located on the levee berm, water pipe, and electrical conduit authorized under Permit No. 8513, 1972 - James A. Fisher). [Additional Reference(s): DWR Levee Log, 2005]. FS Date: 10/23/2019 1:49:00 PM

Electrical conduit visible at pump/wellhead on WS berm.

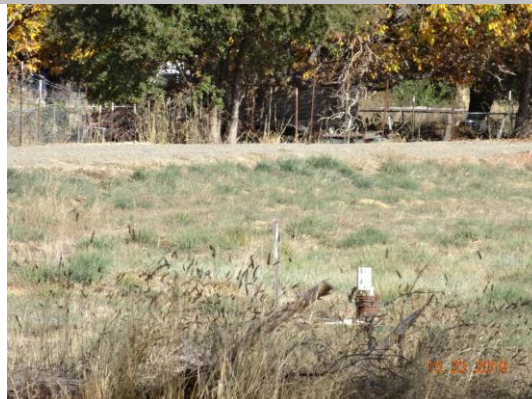
Photo 3 of 3 : UCIP_SP_2020_55729_82582.jpg

LM Start	0.50	Rating **	M	Issue No.	62 (cont)
LM End	0.50	Issue Type +	En	Location *	
Category	Supplemental			GPS Latitude/Longitude	
				Start	End
Item	DWR UCIP Field Study			39.183775 °	39.183775 °
				-122.912187 °	-122.912187 °
DWR ID	21249

WS view: well and other appurtenances located on the WS levee berm.

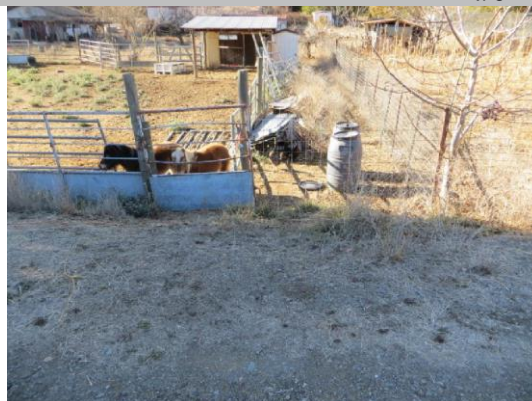
Photo 3 of 3 : UCIP_SP_2020_55728_50391.jpg

DS_ID:21209
FS_ID:55728
EP_NO: 8513
Repair Type: Non-Urgent
Crossing Status: Found
UCIP Comments: 10/23/2019 Record remains Non-Urgent; recommend auditing permit to find current owner and identify if encroachment is still in use. Encroachment appears to be abandoned. If crossing is no longer in use, the owner will need to coordinate with the CVFPB to properly remove or abandon per Title 23 requirements. The UCIP inspection was completed with DWR Inspector, L. Dial, and LMA representative, S. Webb. (O. Magana - DWR UCIP)09/06/2018 Pump no longer in operation. Downgraded from Urgent to Non-Urgent (D. Sanoski - DWR UCIP).11/30/2016 Pipe not in use per LMA representative, Scott Webb. DWR Fall inspection 2016 indicated depression along pipe alignment. According to LMA representative the new property owner is Tracy Joe Hill. Need to contact owner. New owner will need to coordinate with CVFPB regarding permit name change and to address depression noted in the 2016 DWR Fall Inspection . (O. Magana - DWR UCIP)01/14/2014 Appears pipe is leaking on WS toe of Levee at mud pit. (W. Wylie - DWR UCIP) FIELD_STRUCT_DESC: 1 of 2: 1.25-inch steel groundwater pipe through the levee, 2 feet below the levee. Steel cutoff wall around pipe at center of levee. Well with 8-inch casing on waterside (WS) slope. (1.25-inch water pipe and 0.75-inch electrical conduit authorized under Permit No. 8513, 1974 - Fisher)

LM Start	0.50	Rating **	M	Issue No.	63 (cont)	
LM End	0.50	Issue Type +	En	Location *		
Category	Supplemental			GPS Latitude/Longitude		
				Start	End	
Item	DWR UCIP Field Study			39.183775 °	39.183775 °	
				-122.912187 °	-122.912187 °	
DWR ID	21209

Valves visible just off LS toe.

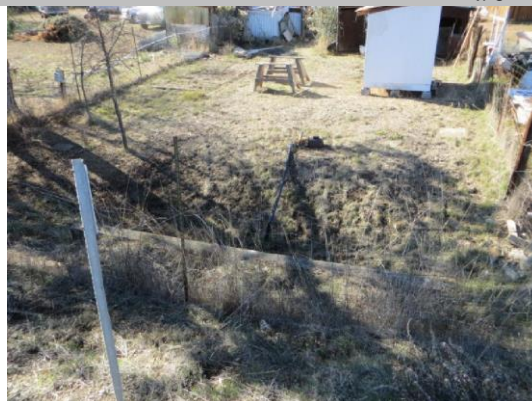
Photo 1 of 3 : UCIP_SP_2020_55730_50411.jpg

Comment Code						
Inspector Comment						
DS_ID:21210 FS_ID:55730 EP_NO: 11482 Repair Type: Non-Urgent Crossing Status: Found UCIP Comments: 10/23/2019 Record remains Non-Urgent; need to audit record to confirm owner. Property owner will also need to address access issue due to fence installed on the LS slope. Crossing has been internally inspected under the DWR DMP Phase 1 project. Inspection report is still not available. The UCIP inspection was completed with DWR Inspector, L. Dial, and LMA representative, S. Webb. (O. Magana - DWR UCIP)01/14/2014 Fence on LS slope creates access issue. (W. Wylie - DWR UCIP) FIELD_STRUCT_DESC: 36-inch corrugated metal drainage pipe through the levee, 9 feet below the crown. Flap gate on the waterside (WS) end. Concrete headwalls on both ends. (36-inch pipe [HLM 0.54] retained under ABO No. 11482, 1975 - George R. and Gladys Schneider). [Additional Reference(s): DWR Levee Log, 2005. USACE Sacramento O&M Manual 506.2, August 1961, (HLM 0.54), Station M294+00, 36-inch pipe, dwg no. CC-4-4-29, Index Sheet 6: page 6, 40 of 64]. FS Date: 10/23/2019 1:50:00 PM

Concrete headwall on LS toe.

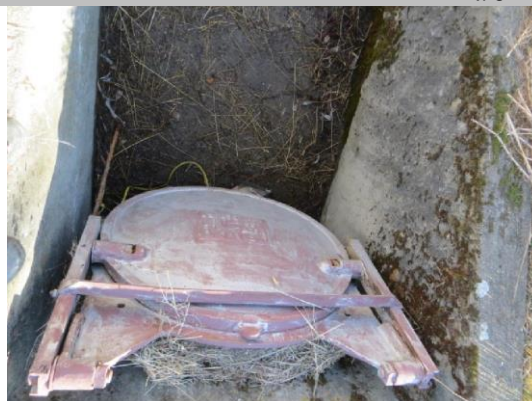
Photo 3 of 3 : UCIP_SP_2020_55730_50409.jpg

LM Start	0.55	Rating **	M	Issue No.	64 (cont)
LM End	0.55	Issue Type +	Ma	Location *	
Category	Supplemental		GPS Latitude/Longitude		
			Start	End	
Item	DWR UCIP LMA Responsibility		39.183130 °	39.183130 °	
			-122.912198 °	-122.912198 °	
DWR ID	21210

Flapgate and concrete headwall on WS berm.

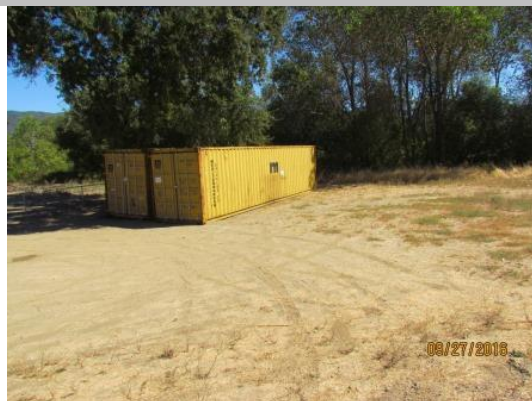
Photo 1 of 1 : SP_2020_NA0009_4_25_20200302_00006.jpg

LM Start	0.96	Rating **	M	Issue No.	25
LM End	0.96	Issue Type +	En	Location *	WS
Category	Earthen Levee			GPS Latitude/Longitude	
				Start	End
Item	Encroachments			39.177249 °	39.177249 °
				-122.913619 °	-122.913619 °
DWR ID	DWR_NA0009_02_f_2016_25				
Comment Code					
BU : Building					
Inspector Comment					
Two 40' shipping containers in the floodway need to be removed.

View of the shipping container in the floodway. Fall 2016

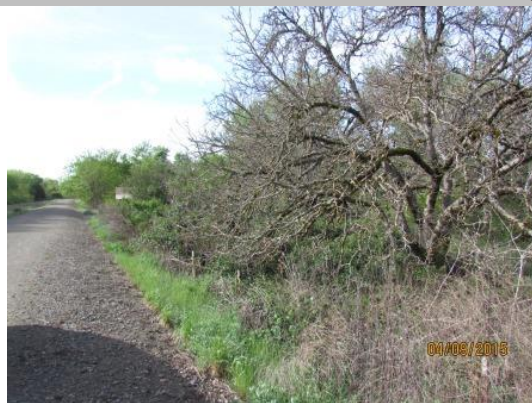
Photo 1 of 1 : SP_2020_NA0009_4_7_20200302_00003.jpg

LM Start	0.97	Rating **	M	Issue No.	7
LM End	0.98	Issue Type +	Ma	Location *	LS
Category	Earthen Levee			GPS Latitude/Longitude	
				Start	End
Item	Vegetation			39.177218 °	39.176992 °
				-122.913673 °	-122.913642 °
DWR ID	DWR_NA0009_02_s_2012_7				
Comment Code					
V2 : Remove the wild growth other than native grasses from the levee slopes.					
Inspector Comment

View of the vegetation at the landside toe.

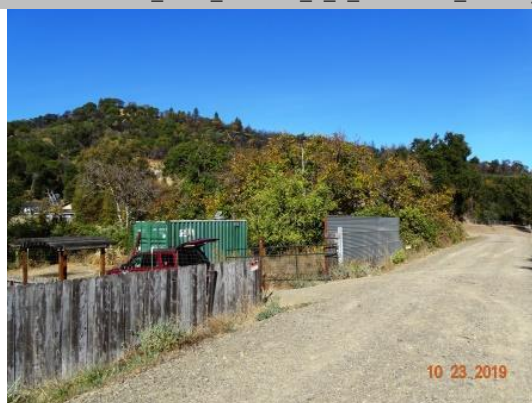
Photo 1 of 1 : SP_2020_NA0009_4_2_20200302_00002.jpg

LM Start	0.99	Rating **	U	Issue No.	2
LM End	0.99	Issue Type +	En	Location *	LS
Category	Earthen Levee			GPS Latitude/Longitude	
				Start	End
Item	Encroachments			39.176815 °	39.176815 °
				-122.913540 °	-122.913540 °
DWR ID	DWR_NA0009_02_s_2012_2				
Comment Code					
FE : Fence					
Inspector Comment					
An unpermitted fence runs along the landside toe.

View of wooden and sheet metal fence along the levee toe. Fall 2019

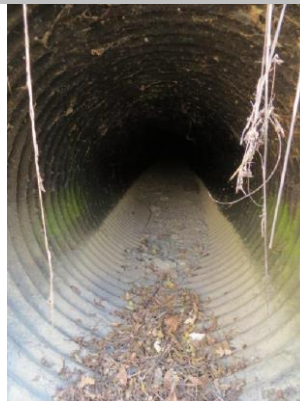
Photo 2 of 3 : UCIP_SP_2020_55740_51201.jpg

Comment Code						
Inspector Comment						
DS_ID:21211 FS_ID:55740 EP_NO: 11486 Repair Type: Non-Urgent Crossing Status: Found UCIP Comments: 10/23/2019 Record has been updated from No Action Needed to Non-Urgent; need to audit record to confirm owner. Crossing has been internally inspected under the DWR DMP Phase 1 project. Inspection report is still not available. The UCIP inspection was completed with DWR Inspector, L. Dial, and LMA representative, S. Webb. (O. Magana - DWR UCIP) FIELD_STRUCT_DESC: 36-inch corrugated metal drainage pipe through the levee, 7.3 feet below the crown. Flap gate on the waterside (WS) end. Concrete headwalls on both ends. Splash apron broken off on the WS end. (36-inch pipe [HLM 1.08] retained under Automatic Board Order (ABO) issued as Permit No. 11486, 1975 - Mary Truesdell). [Additional Reference(s): DWR Levee Log, 2005. USACE Sacramento O&M Manual 506.2, August 1961, (HLM 1.08), Station M269+00, 36-inch pipe, dwg no. CC-4-4-29, Index Sheet 5: page 5, 39 of 64]. FS Date: 10/23/2019 1:16:00 PM

LM Start	1.03	Rating **	M	Issue No.	65 (cont)
LM End	1.03	Issue Type +	Ma	Location *	
Category	Supplemental		GPS Latitude/Longitude		
			Start	End	
Item	DWR UCIP LMA Responsibility		39.176366 °	39.176366 °	
			-122.913509 °	-122.913509 °	
DWR ID	21211

Pipe as visible from LS toe.

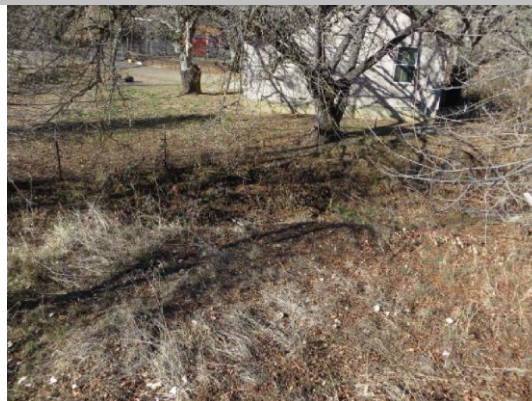
Photo 3 of 3 : UCIP_SP_2020_55740_51200.jpg

Pipe visible on LS toe.

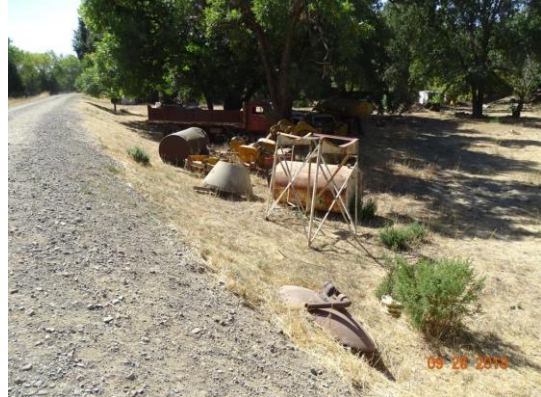
Photo 1 of 1 : SP_2020_NA0009_4_31_20200302_00011.jpg

LM Start	1.05	Rating **	M	Issue No.	31
LM End	1.06	Issue Type +	En	Location *	LS
Category	Earthen Levee			GPS Latitude/Longitude	
				Start	End
Item	Encroachments			39.176008 °	39.175810 °
				-122.913482 °	-122.913367 °
DWR ID	DWR_NA0009_02_f _ 2018_31				
Comment Code					
EQ : Equipment					
Inspector Comment					
Move equipment to at least 10' away from the levee toe.

View of equipment along the landside toe. Fall 2018

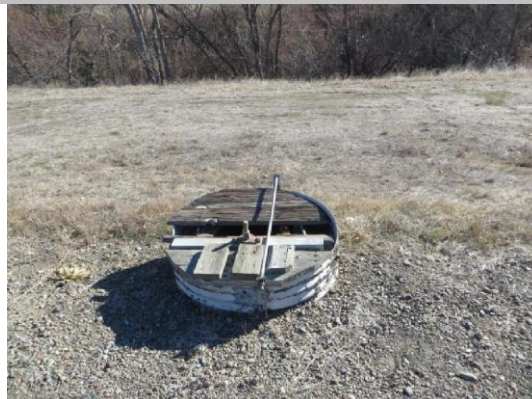
Photo 1 of 3 : UCIP_SP_2020_55741_51214.jpg

Comment Code						
Inspector Comment						
DS_ID:21212 FS_ID:55741 EP_NO: 11483 Repair Type: Non-Urgent Crossing Status: Found UCIP Comments: 10/23/2019 Record remains Non-Urgent, crossing appears abandoned; need to audit record to confirm owner. Crossing has been internally inspected under the DWR DMP Phase 1 project. Inspection report is still not available. The UCIP inspection was completed with DWR Inspector, L. Dial, and LMA representative, S. Webb. (O. Magana - DWR UCIP)01/22/2014 Pipe appears abandoned and if so, should be done so properly. Debris blocking flap gate at outlet. (W. Wylie - DWR UCIP) FIELD_STRUCT_DESC: *ABANDONED* 30-inch corrugated metal drainage pipe through the levee, 17.8 feet below the crown. Slide gate in 44-inch corrugated metal riser unit on the waterside (WS) slope. Flap gate on the WS end at concrete headwall. 6-foot by 8-foot concrete sump at the landside (LS) toe. (30-inch pipe [HLM 1.22] retained under Automatic Board Order (ABO) issued as Permit No. 11483, 1975 - Edward M. and Mildred E. Seely). [Additional Reference(s): DWR Levee Log, 2005. USACE Sacramento O&M Manual 506.2, August 1961, (HLM 1.22)]. FS Date: 10/23/2019 1:16:00 PM

Slide gate in 44-inch CMP riser on WS shoulder.

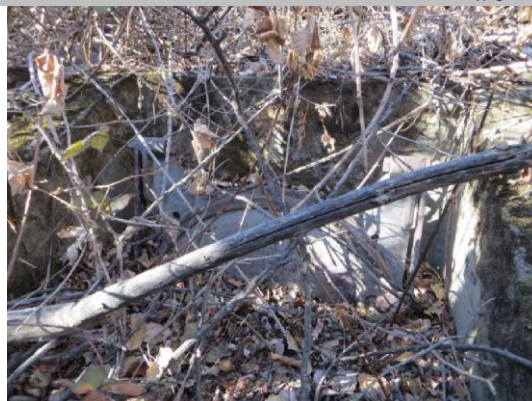
Photo 3 of 3 : UCIP_SP_2020_55741_51215.jpg

Flapgate and concrete headwall visible off WS berm.

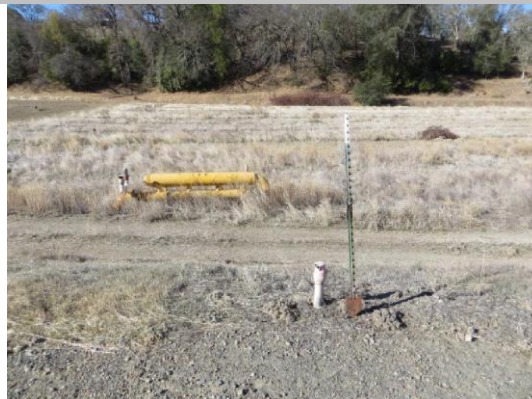
Photo 2 of 3 : UCIP_SP_2020_55742_51241.jpg

DS_ID:21213
 FS_ID:55742
 EP_NO: 16177
 Repair Type: Non-Urgent
 Crossing Status: Found
 UCIP Comments: 10/23/2019 Record has been updated from No Action Needed to Non-Urgent, pipe appears to be abandoned; need to audit record to confirm owner. Pipe owner has removed pump and pipe section from the WS. The UCIP inspection was completed with DWR Inspector, L. Dial, and LMA representative, S. Webb. (O. Magana - DWR UCIP)
 FIELD_STRUCT_DESC: 10-inch coated steel irrigation pipe through the levee, 2 feet below the crown. Siphon breaker on apex of pipe at the landside (LS) shoulder. Exposed filter on LS slope. Seasonal pump on the waterside (WS) slope. (12-inch pipe authorized under Permit No. 16177, 1994 - Edward Seely). [Additional Reference(s): DWR Levee Log, 2005].
 FS Date: 10/23/2019 1:17:00 PM

Vent on LS shoulder with filter plant visible at LS toe in background.

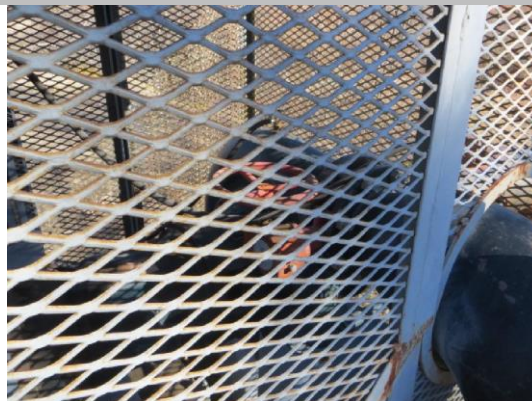
Photo 3 of 3 : UCIP_SP_2020_55742_51240.jpg

Gate valve visible at portable pump on WS toe.

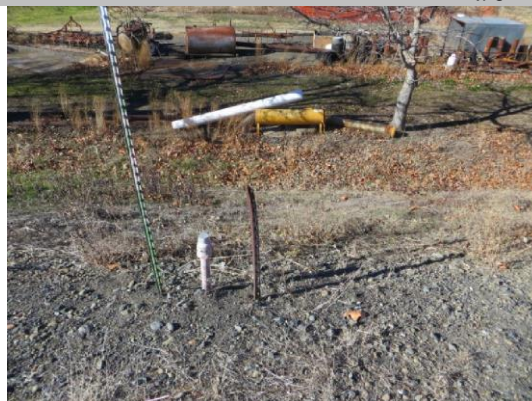
Photo 1 of 3 : UCIP_SP_2020_55865_51250.jpg

Comment Code						
Inspector Comment						
DS_ID:21214 FS_ID:55865 EP_NO: 15825 Repair Type: Non-Urgent Crossing Status: Found UCIP Comments: 10/23/2019 Record remains Non-Urgent, pipe appears to be abandoned; need to audit record to confirm owner. Pipe owner has sealed WS pipe. The UCIP inspection was completed with DWR Inspector, L. Dial, and LMA representative, S. Webb. (O. Magana - DWR UCIP)01/22/2014 Pipe with closure device not visible on WS toe. Clear soil from pipe and cover for better verification of closure. (W. Wylie - DWR UCIP) FIELD_STRUCT_DESC: 8-inch steel irrigation pipe through the levee, 2 feet below the crown. Siphon breaker on apex of pipe at the landside (LS) shoulder. Exposed filter on LS slope. Seasonal pump on the waterside (WS) slope. (10-inch pipe authorized under Permit No. 15825, 1992 - Edward Seely, 8-inch pipe installed instead of 10-inch pipe per inspector's notes dated 9-25-92). [Additional Reference(s): DWR Levee Log, 2005]. FS Date: 10/23/2019 1:18:00 PM

Vent on LS shoulder with filter visible on LS toe.
